## **APPENDIX L**

### Photographs

Appendix L. Photographs taken throughout the study watersheds. The first section of photographs include images captured at representative sites throughout the watersheds. The last section (L17-L22) includes photographs taken of culverts located downstream from discharge monitoring locations. These photographs were taken to help assess how similar (e.g., unobstructed) the culvert openings were prior to each monitoring event. Photographs were not collected prior to the first storm (3/28/00) because a camera was not available at the time (culverts were cleaned just before sampling/monitoring occurred).

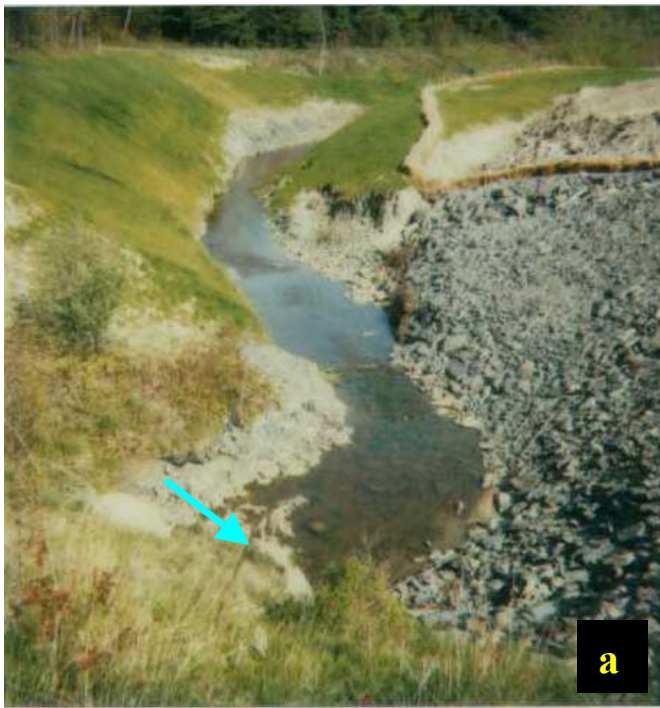
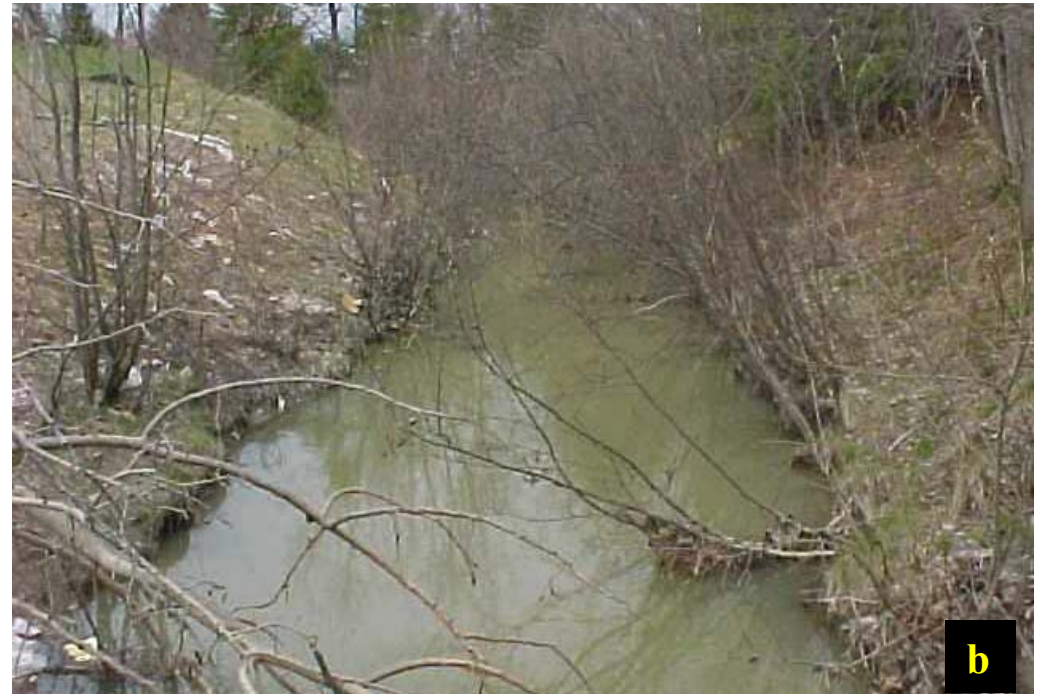
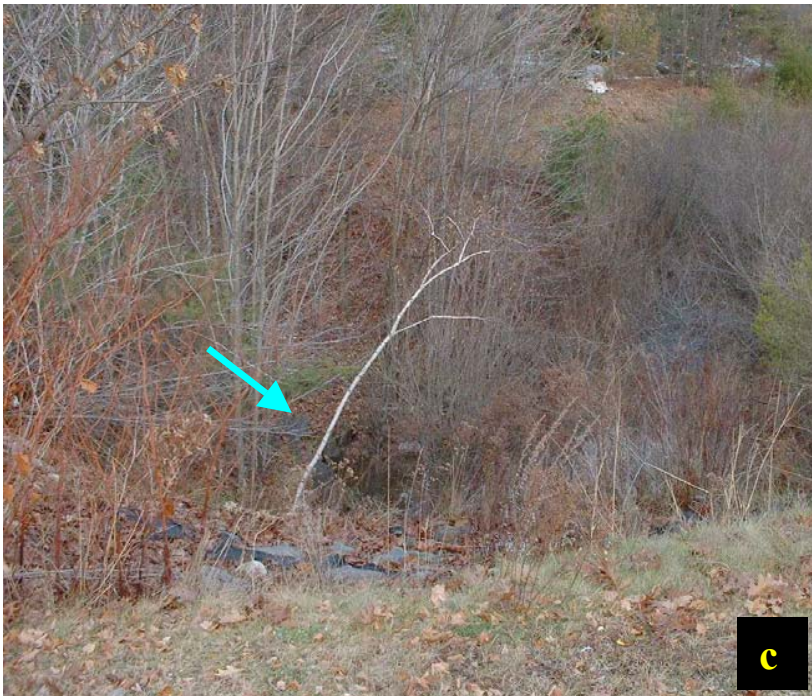
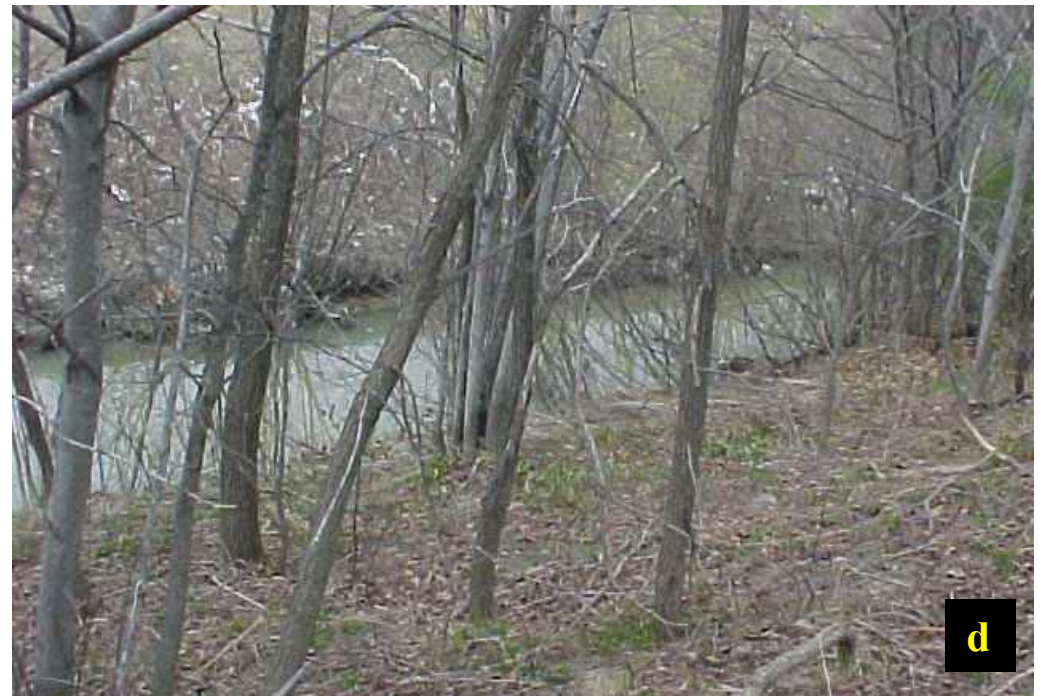
Appendix L-11. Photographs taken of LC-M-0.5~ immediately below Foden Road on 5/18/83 (a) and 11/26/02 (c). Notice the apparent filling activity and riprap on the streambanks and in the channel. The arrow points to the top of the culvert underneath the road. Photographs b and d were taken on 4/18/01 of a channelized section of the stream approximately 100-m downstream from photographs a and c.

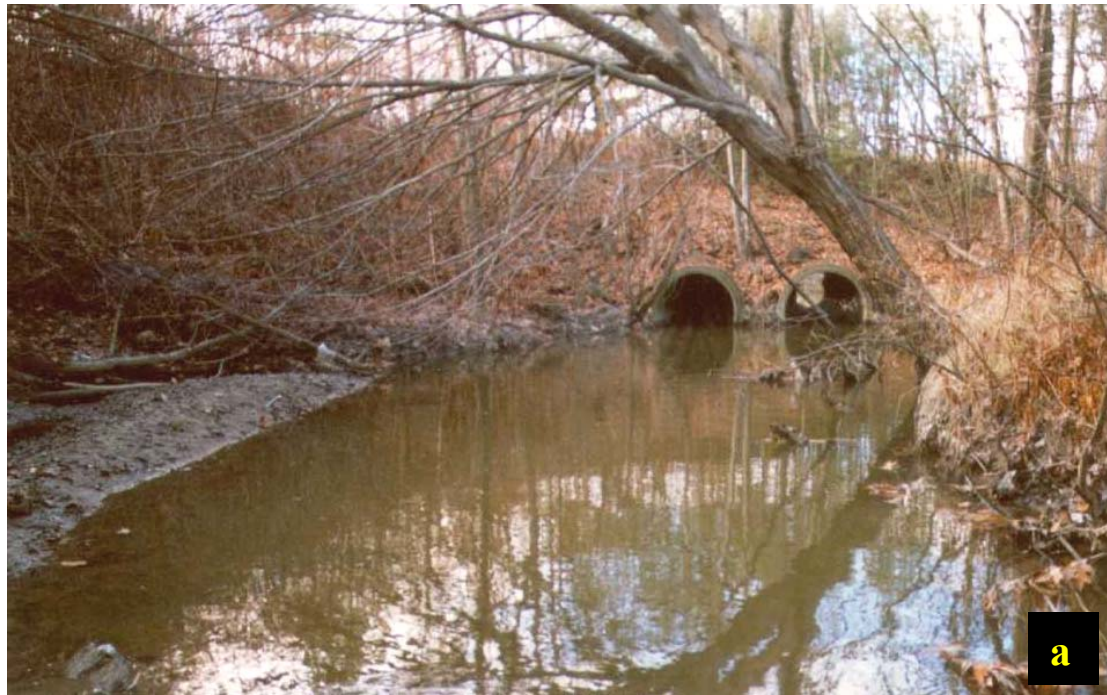
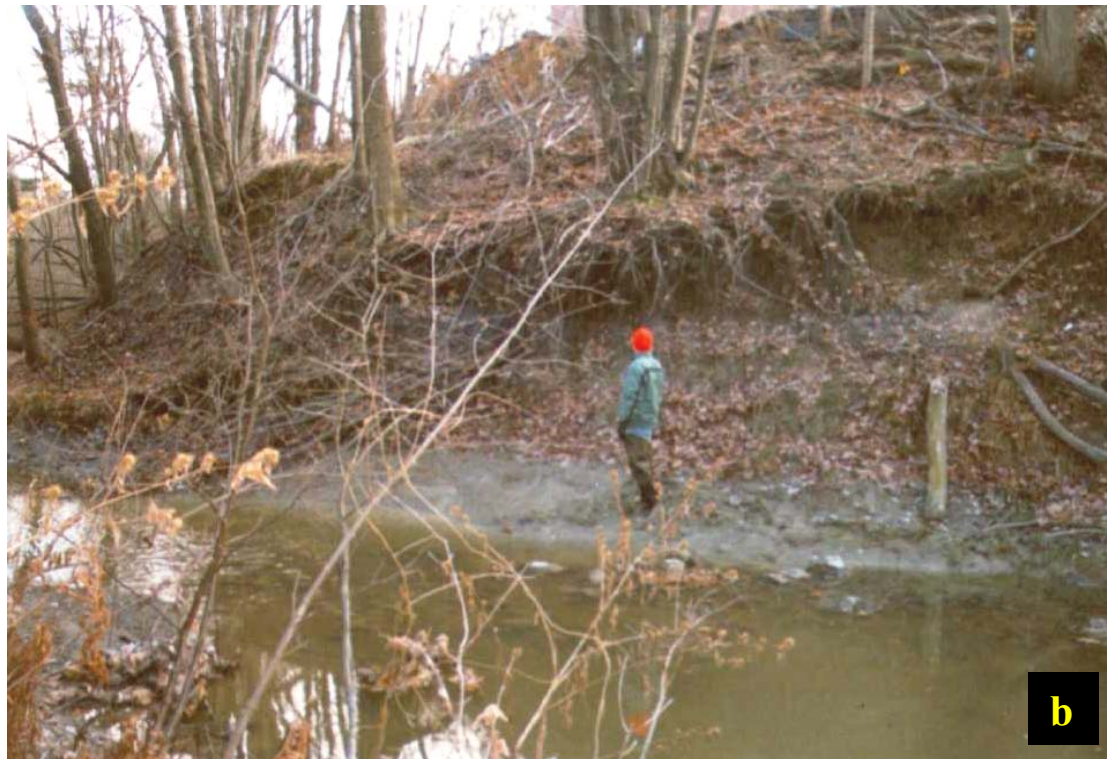
Appendix L-12. Photographs taken on 12/1/00 at approximately LC-M-0.4~. Notice the wide, deep channel beneath the culvert (a) and the severe erosion on the bank opposite the culvert (b).

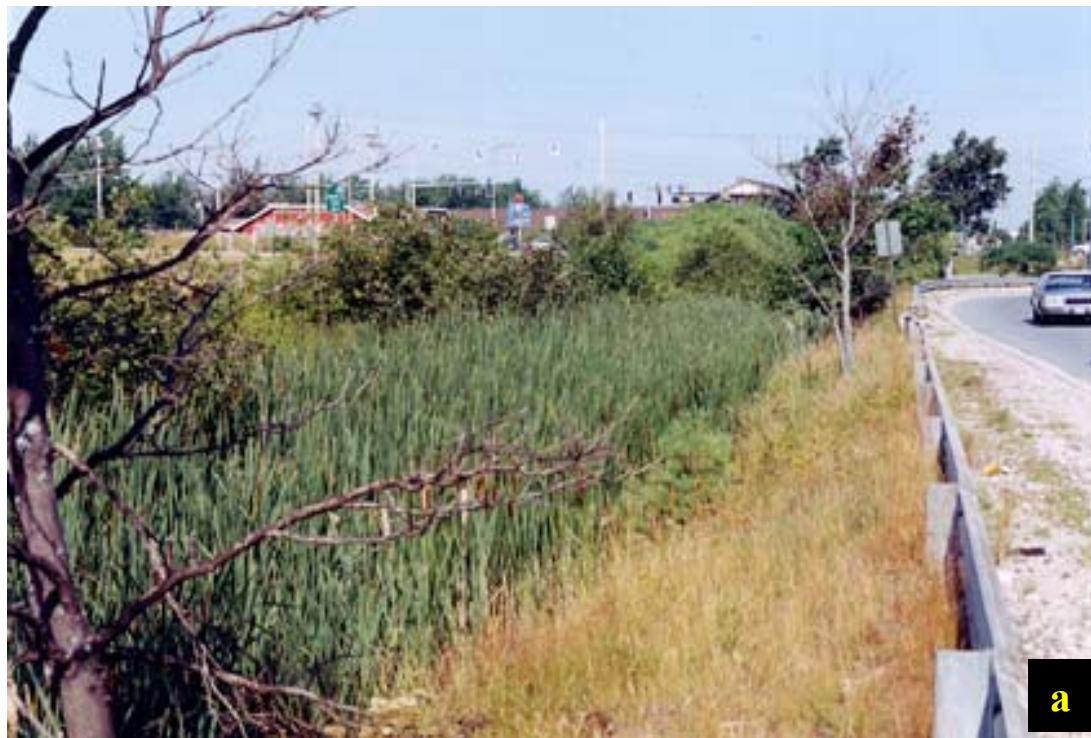
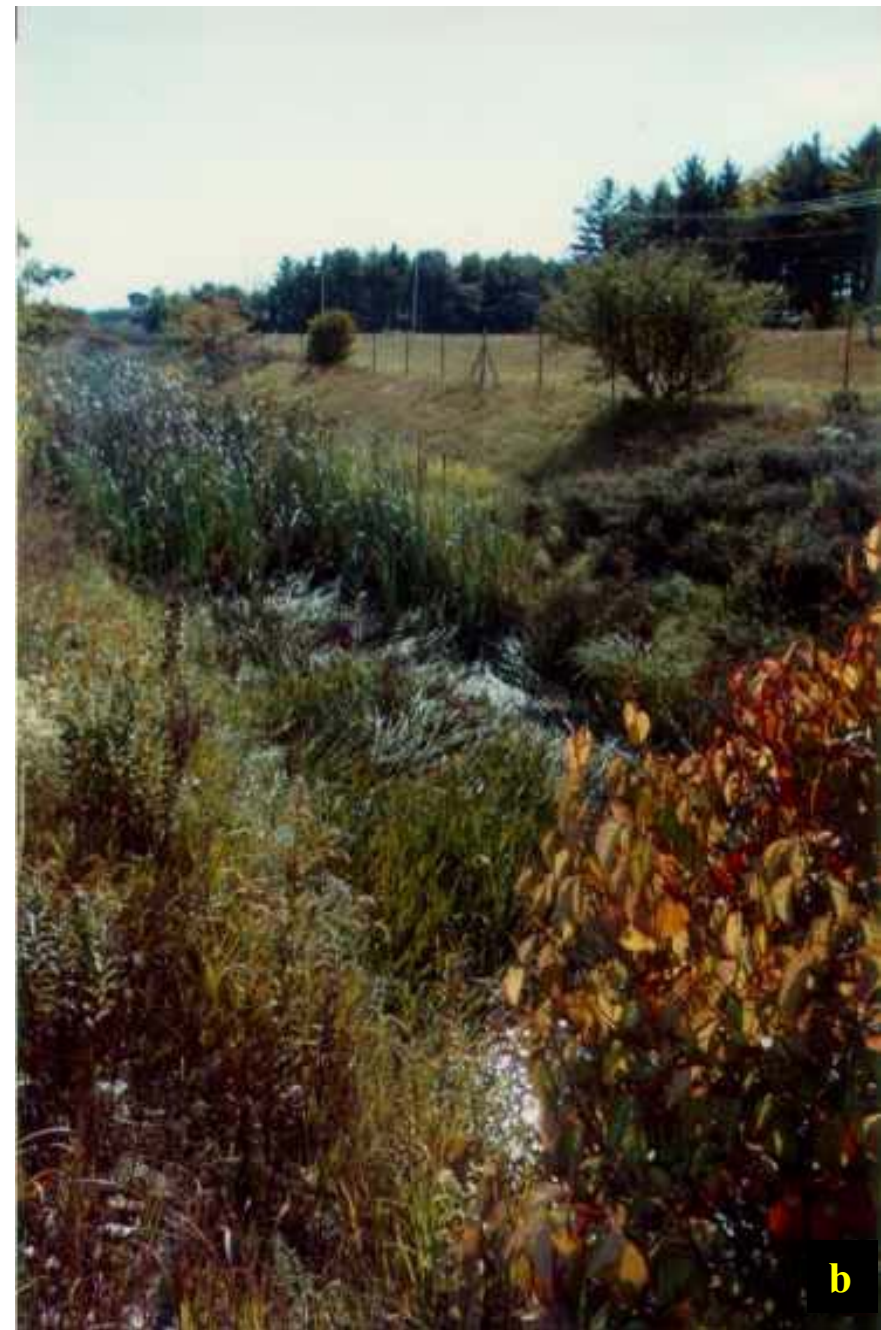
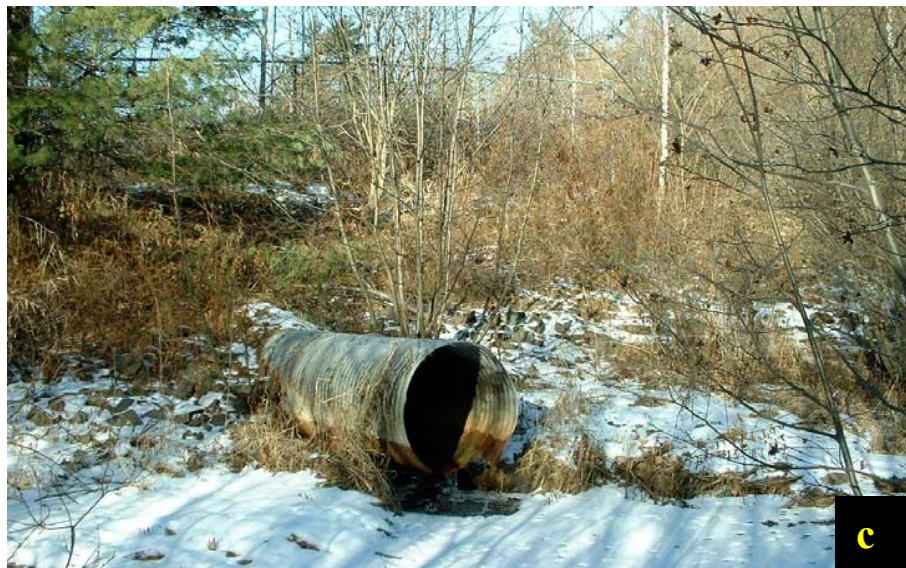
Appendix L-13. Photographs taken of channelized stream reaches near LC-S-1.0~ (a,b) and of a stormwater detention pond outlet near LC-S-0.5. Dates: 9/25/99 (a-b), and 12/9/02 (c).

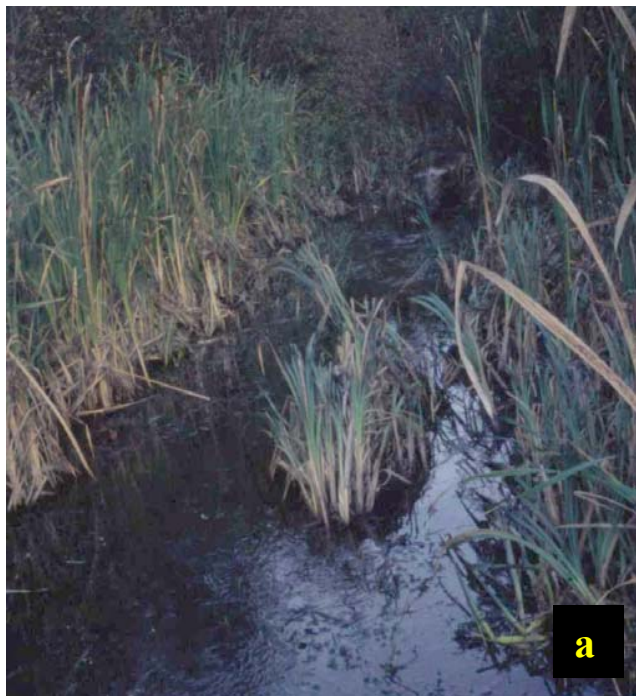
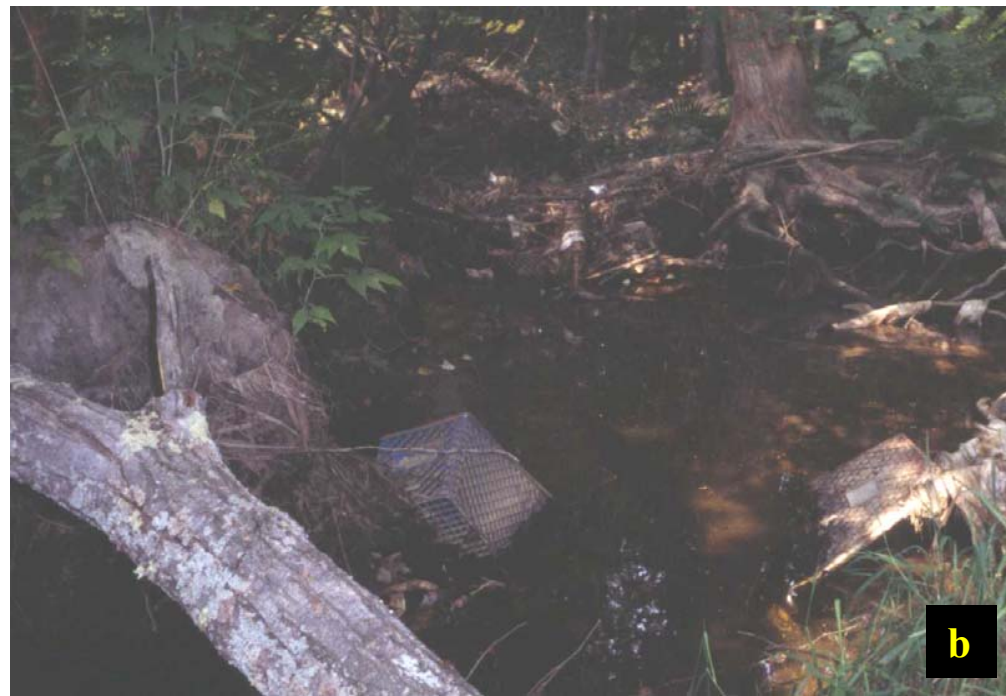
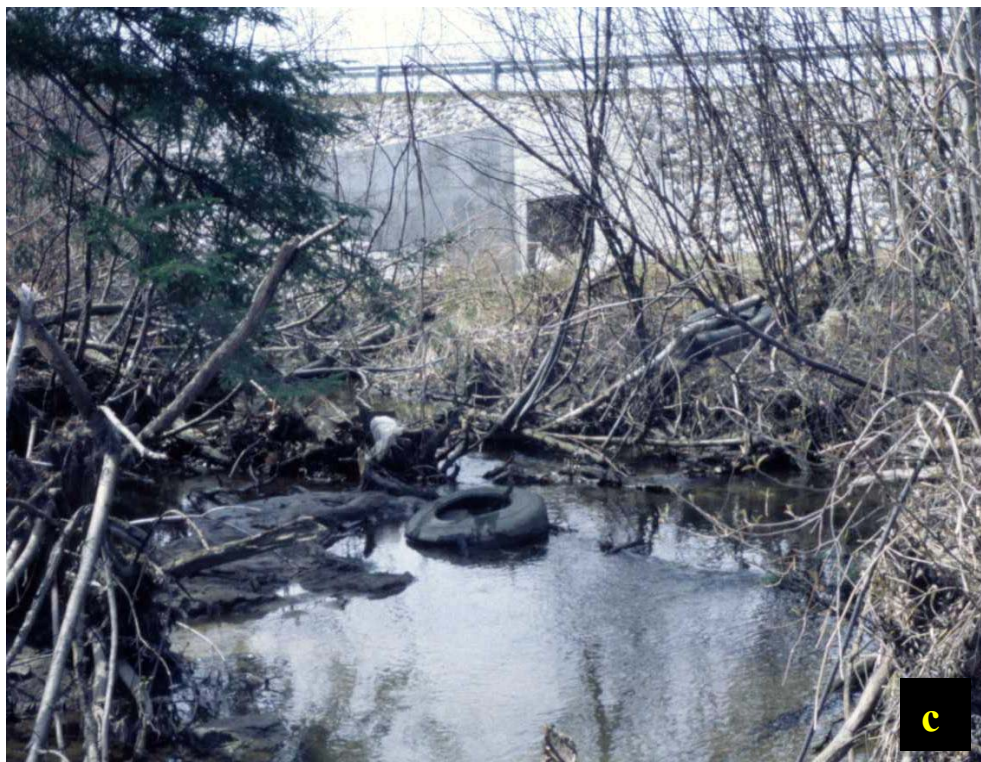
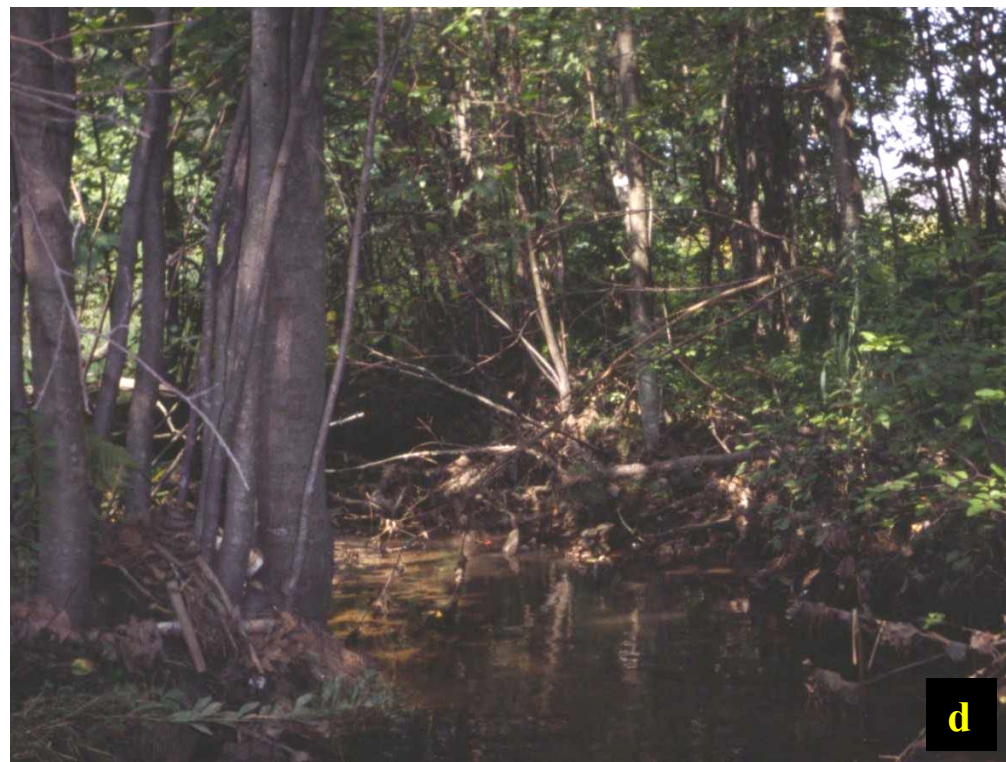
Appendix L-14. Photographs taken of LC-S near stream mile 0.6~ (a) and 0.4~ (b,d) and also near stream mile 0.2~ (c). Dates: 9/22/99 (a,b,d) and 4/17/00 (c). Note shopping carts in photo b and a tire in photo c.

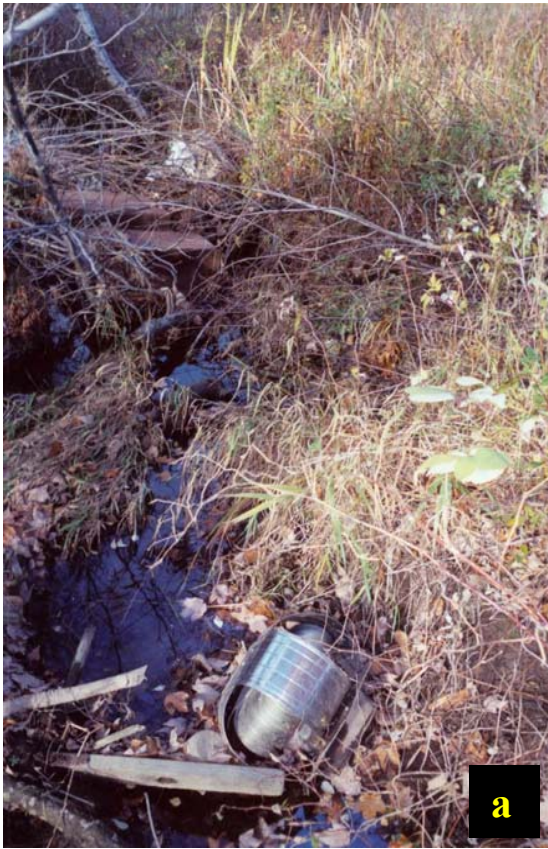
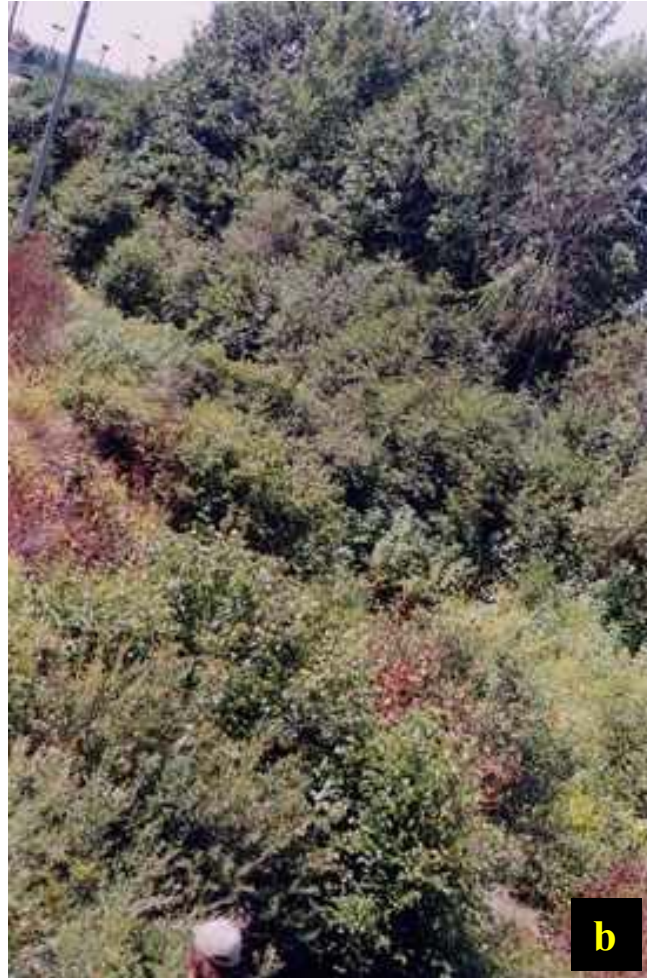
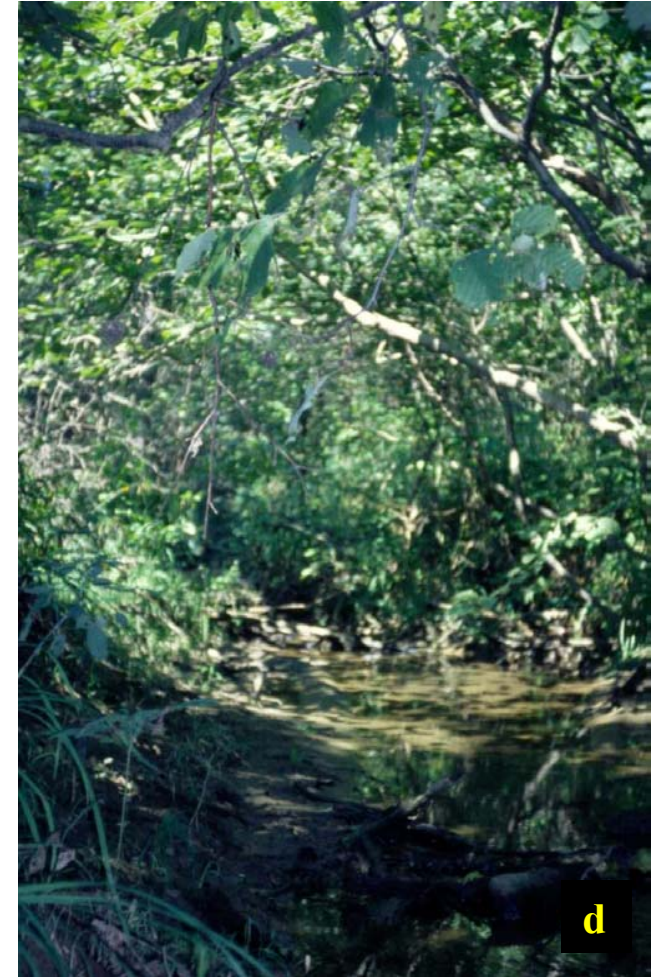
Appendix L-15. Photographs taken of some trash (a), a powerline area (b; *photo is slightly tilted*), a stormwater outfall pipe (c), and a shaded reach (d) at LC-N near stream mile 0.85 (a,b), 0.6 (c), and 0.4 (d).

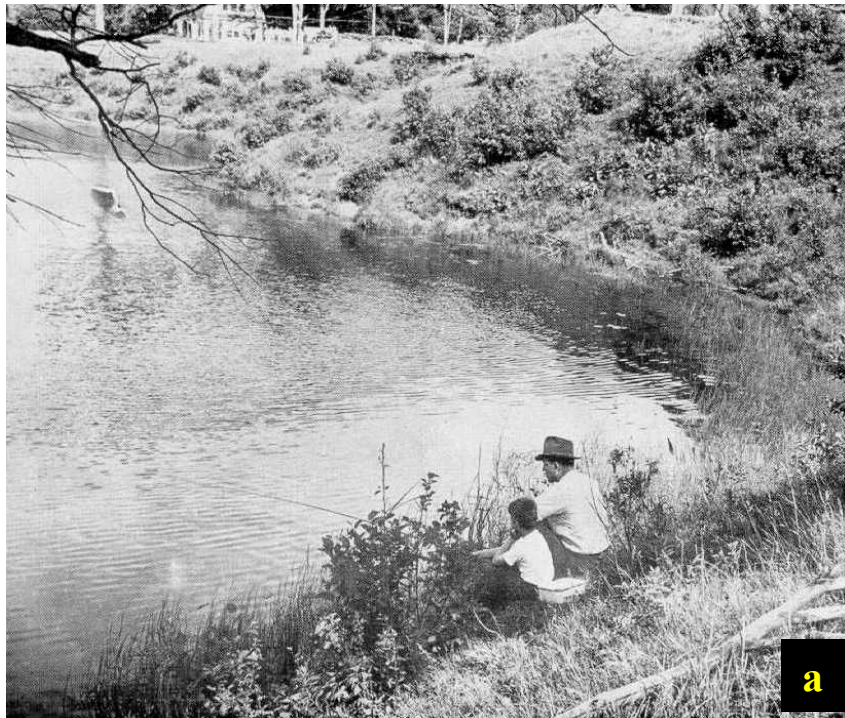
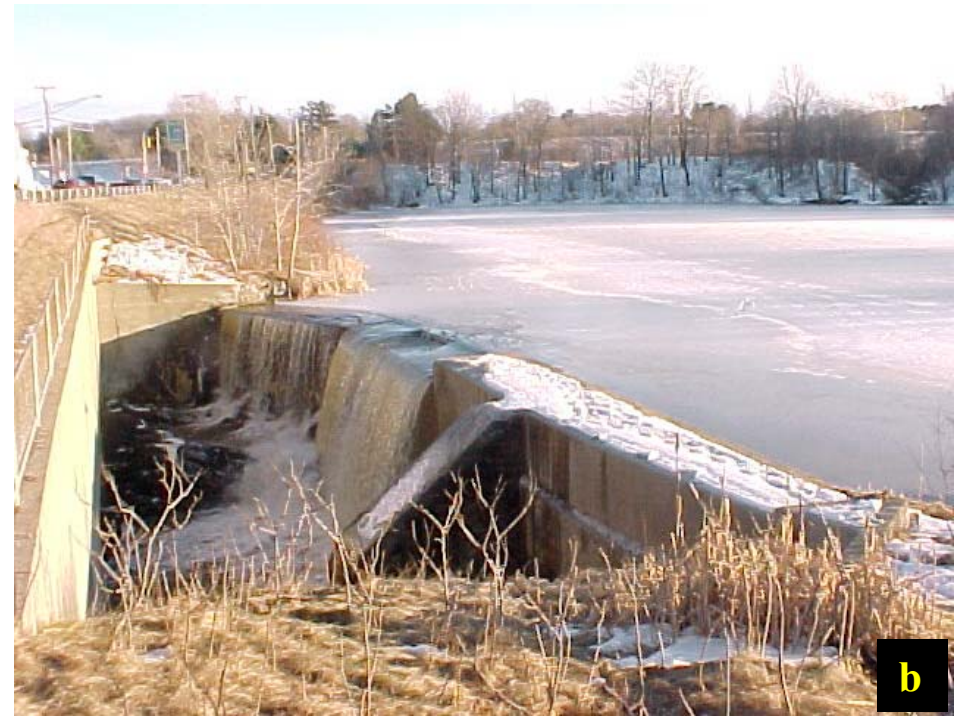
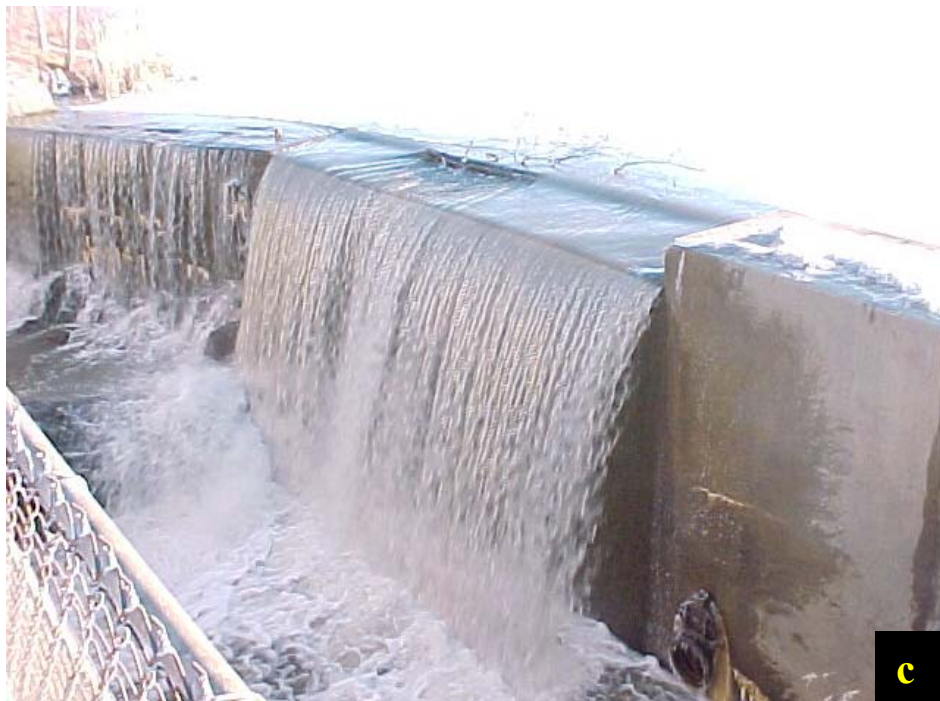
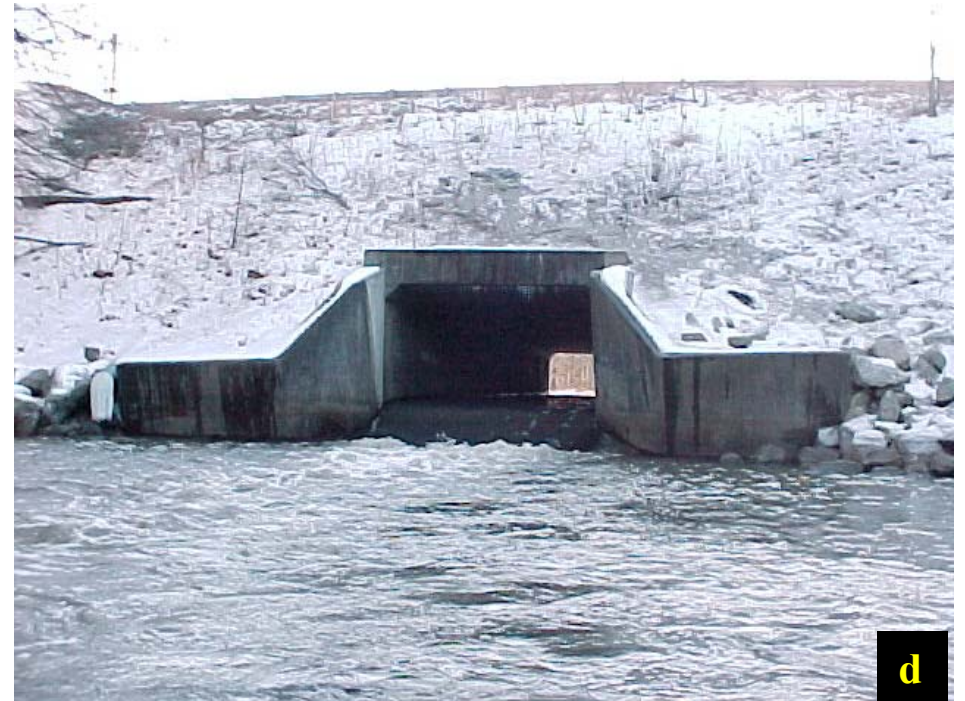
Appendix L-16. Photographs taken of people fishing Clark's Pond circa the 1950s (?) (a; from Seeley and Valle 1983) and also of the dam at the base of the pond on 2/11/02 (b-d).
